Subjects: Dock and Sea Trials "RTA 1" Catamaran Passenger Ferry
Metal Shark Franklin, LA.

The following was observed during my visit of April 27, 2018

First Catamaran Ferry "RTA 1"

Two (2) 32.0 (m) X 7.7 (m) X 1.35(m)RTA Passenger Ferries

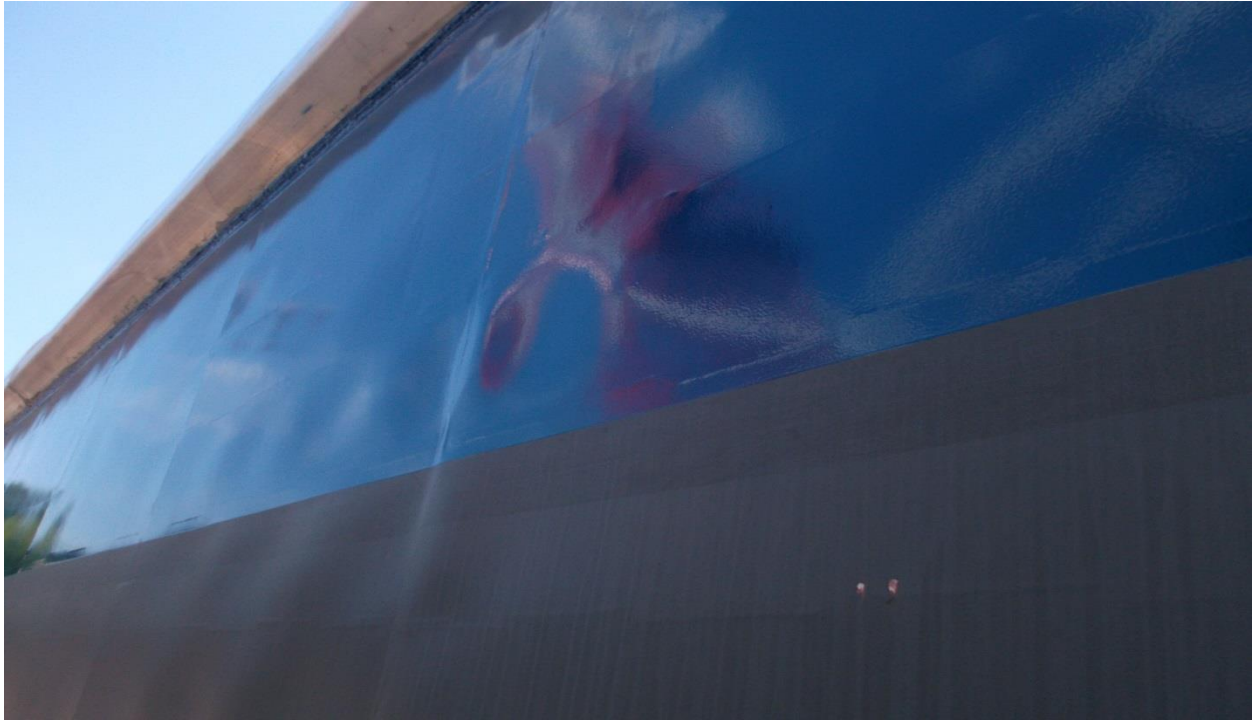
First Catamaran Ferry "RTA 1": The areas having the majority of the deflection/distortion in the shell plating were observed internally with areas between longitudinal members, near bulkheads and piping appendages found to have some distortion noted. There was no notable

deformation noted to the internal members but some small gaps were noted on the starboard forward between the side shell plating and longitudinal members.

Portside views near mid-ship and forward deflection/distortion noted on shell plating

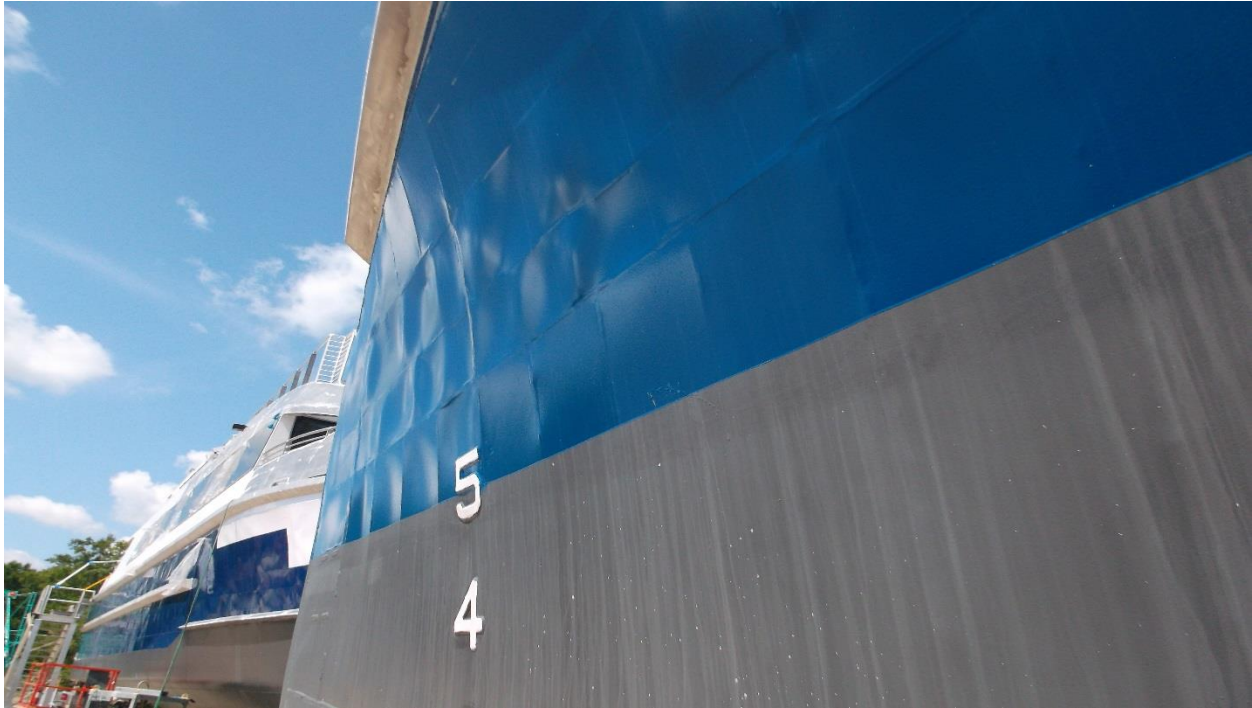
Portside bow shell plating deflection/distortion

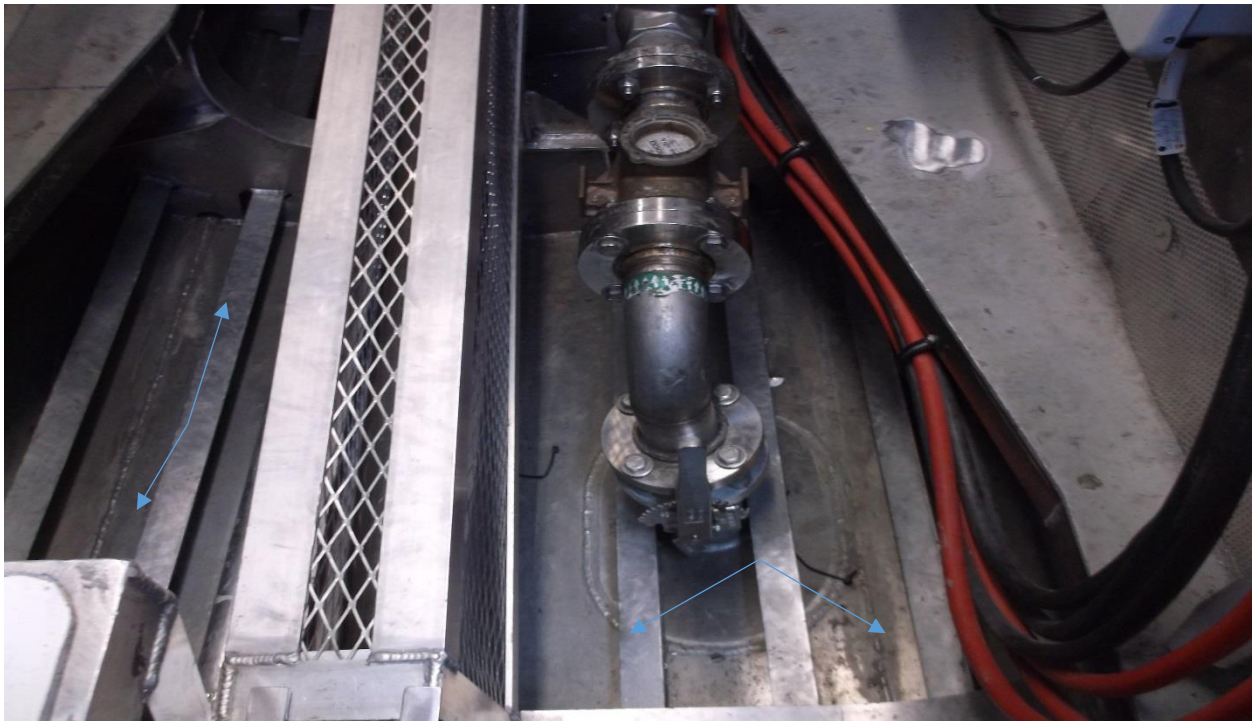
Areas inside aft machinery space in need of floor plating. Floor plates and gratings noted on page 26, section 211.1 of the technical specifications. Others areas in need of floor plates shown in the proceeding photos,

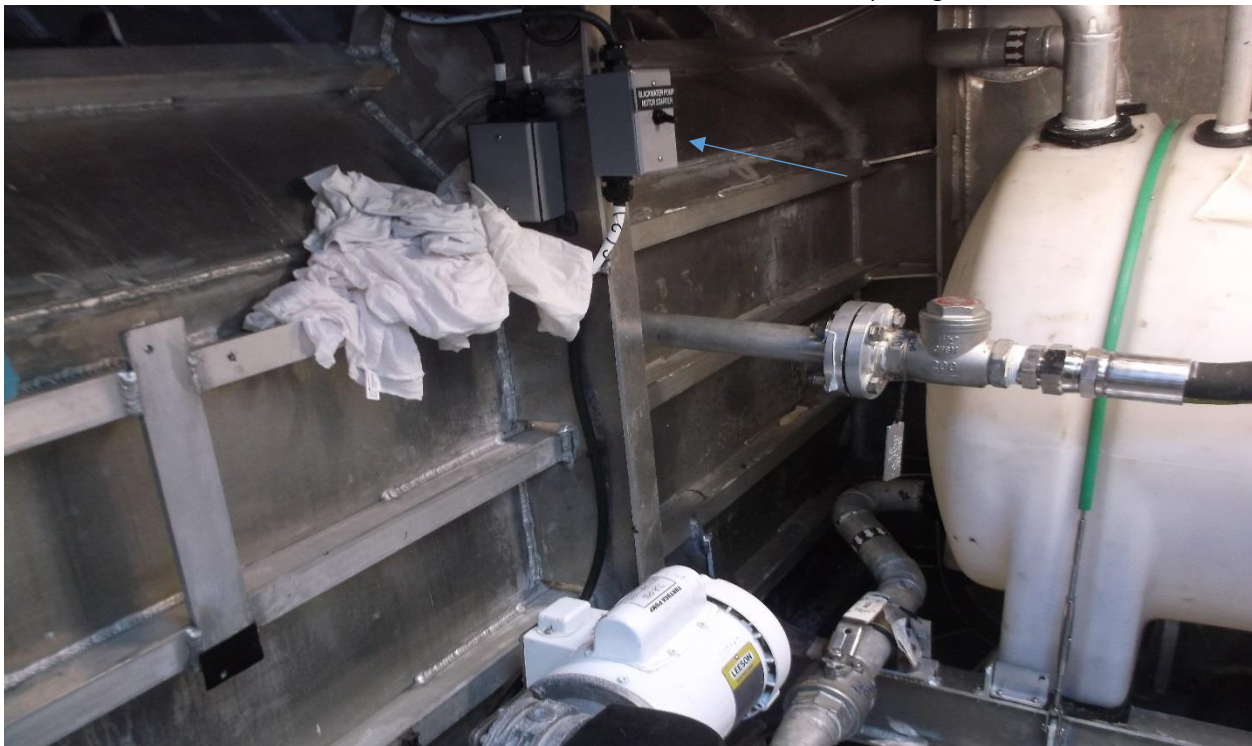
The switch as noted by arrow is for pumping off sewage tank; specification state it is on deck by the pump out fittings, see next photo

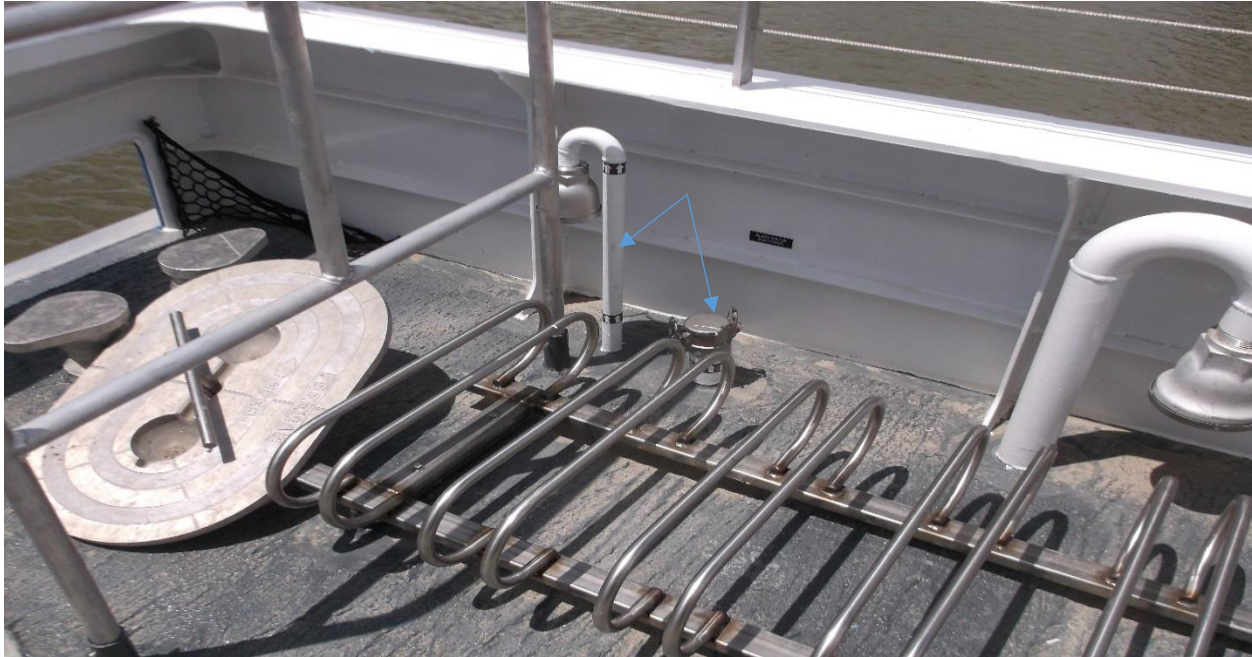
The arrows show the gray water sewage tank pump off location. Specifications state there is a control for pumping off here which is not there

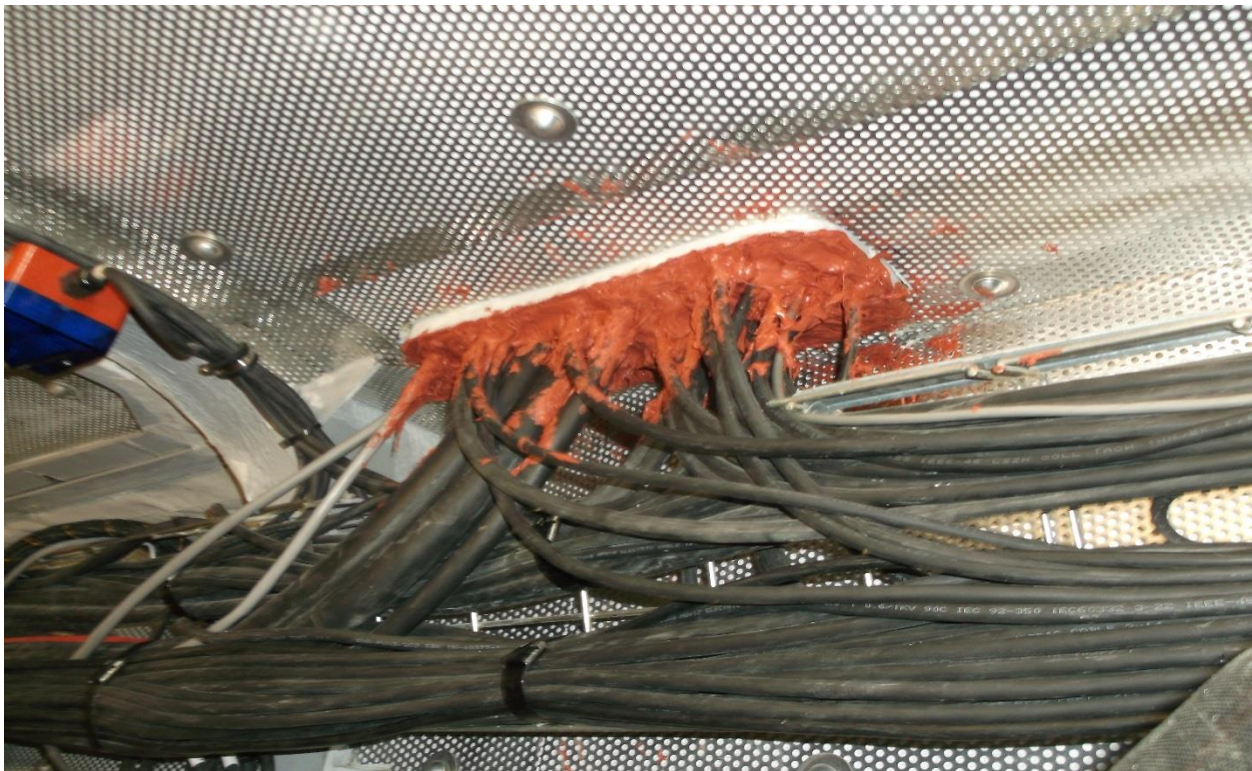
Sloppy fire block compound with questionable sealing of cable passage area in machinery spaces (safety/fire issue)

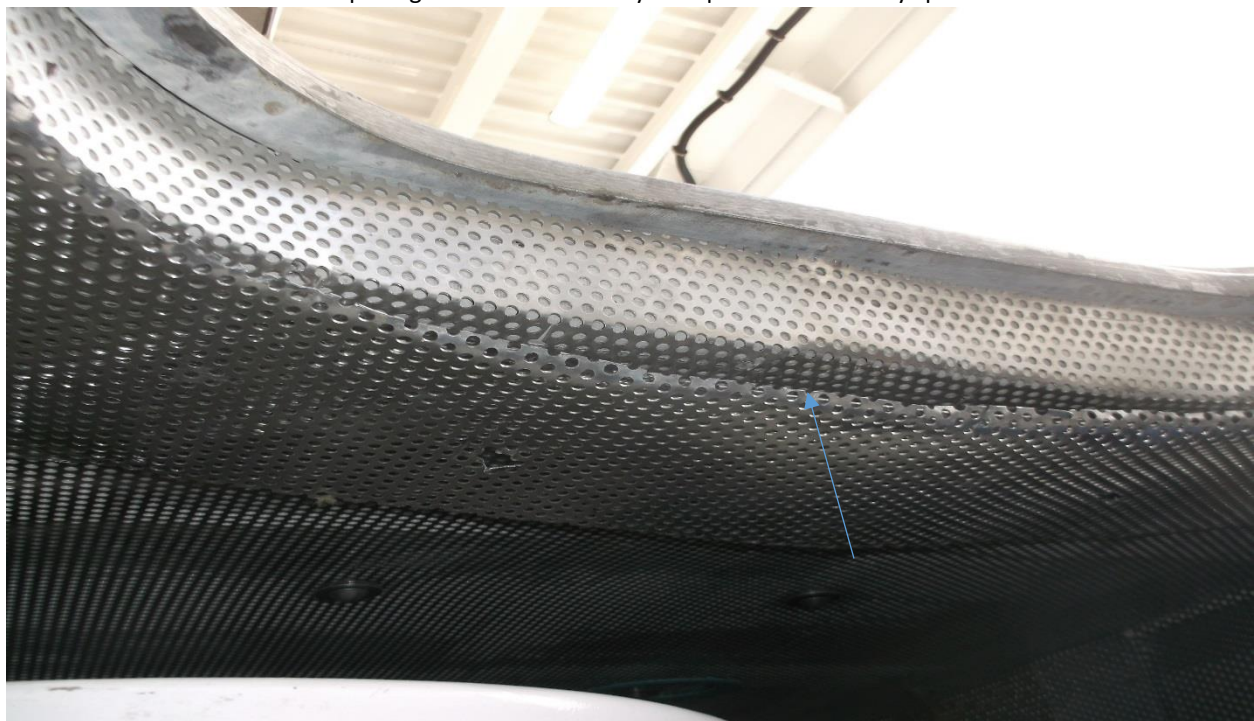
View of loose overhead perforated sheathing inside aft port machinery space hatch

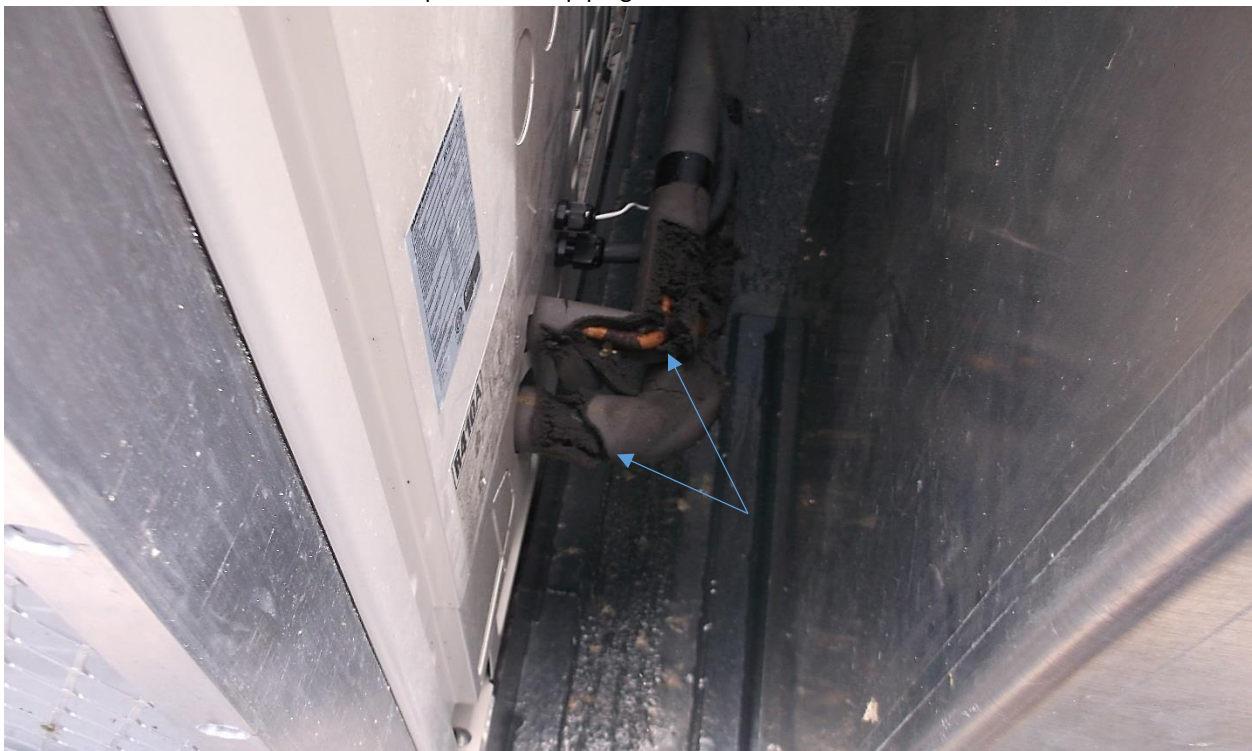
View of damaged refrigerant tubing insulation at HVAC condenser units of upper deck

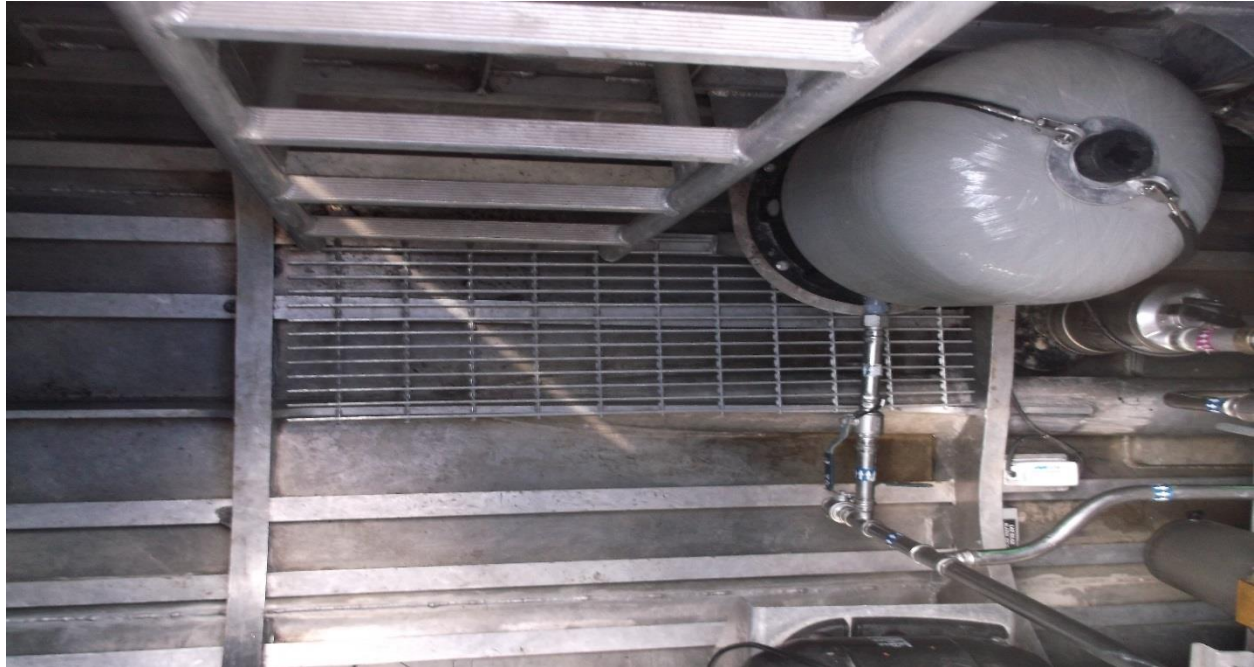
View of loose grating inside no.5 port steering gear void

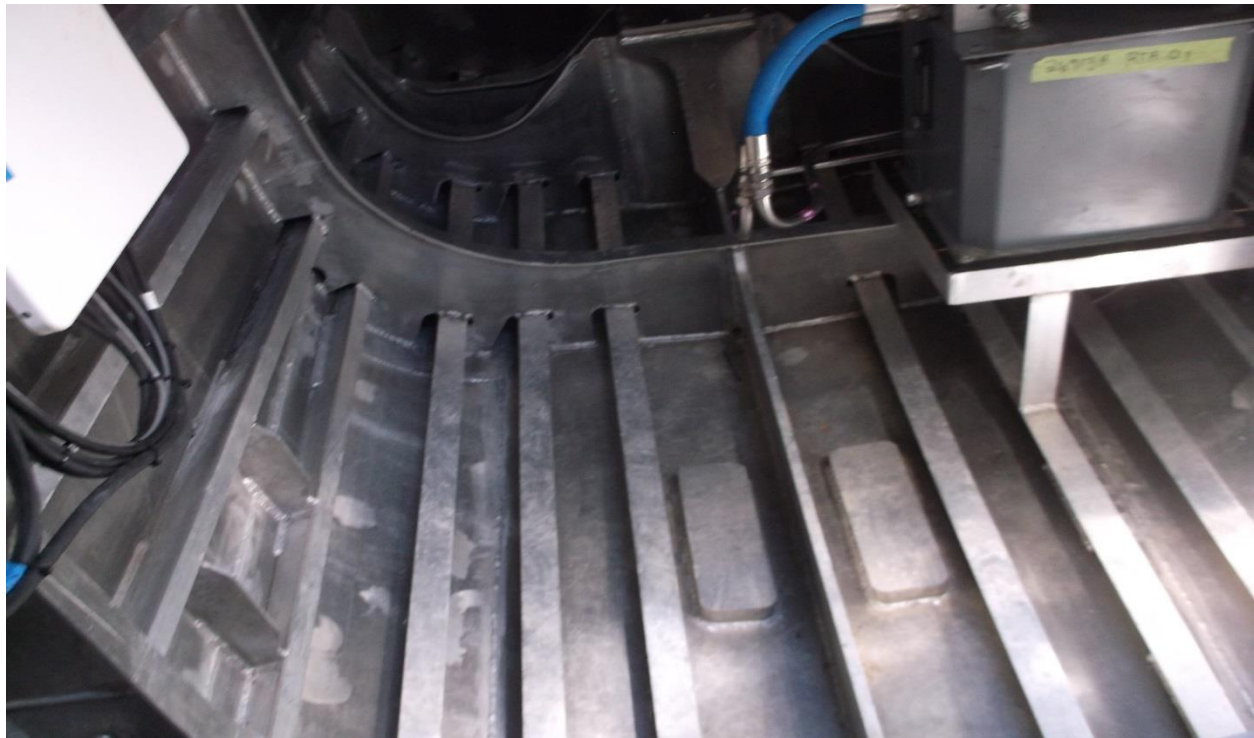
View looking aft inside no.5 port steering void without grating

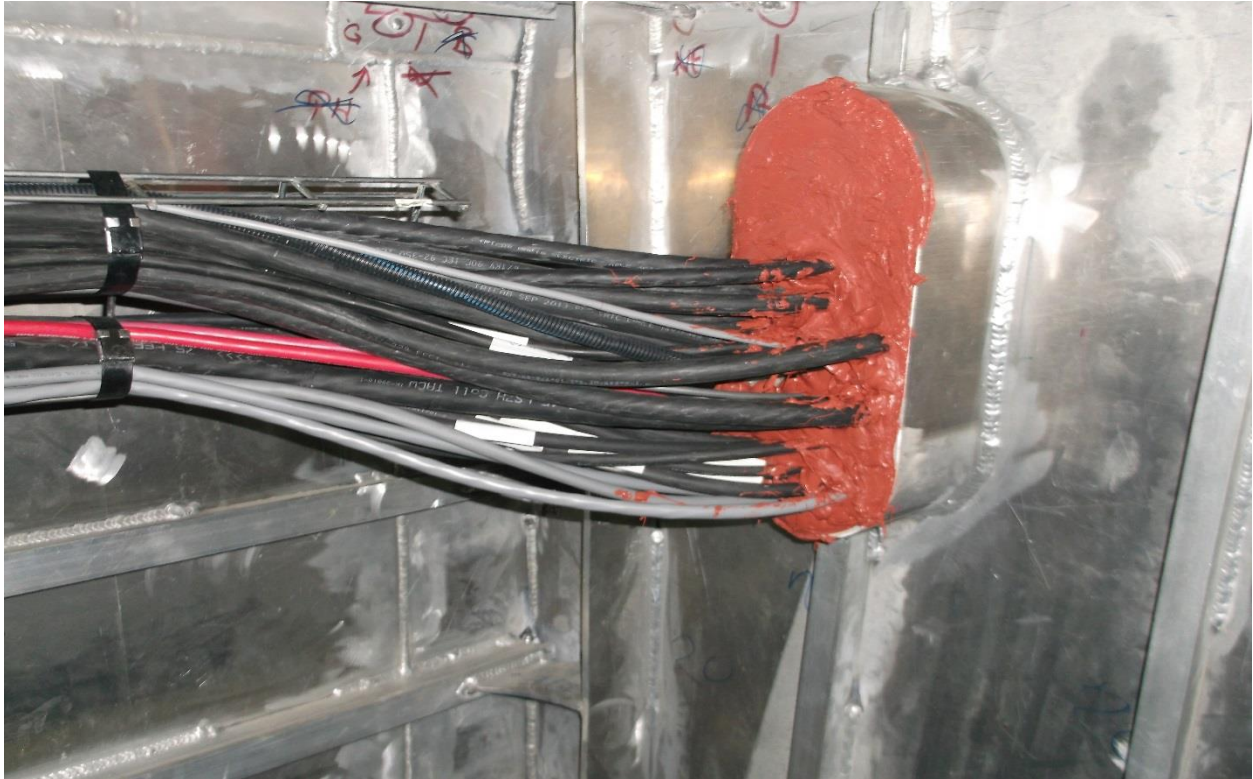
Views from various areas where fire block compound was sloppily applied to bulkhead passages

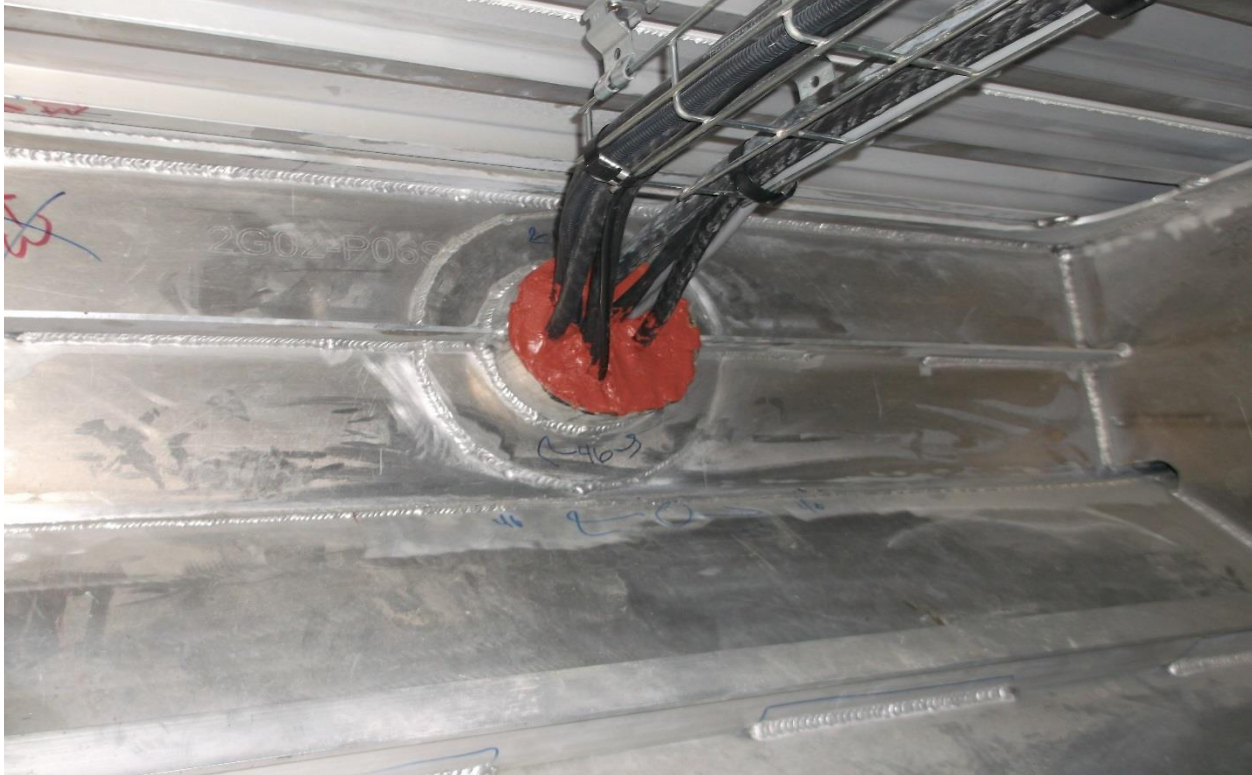
More view of fire block compound sloppily applied inside hull voids
